Pier 4 Phase 1
Removal Action Project

Time Critical Removal
Action Completion Report

July 2016

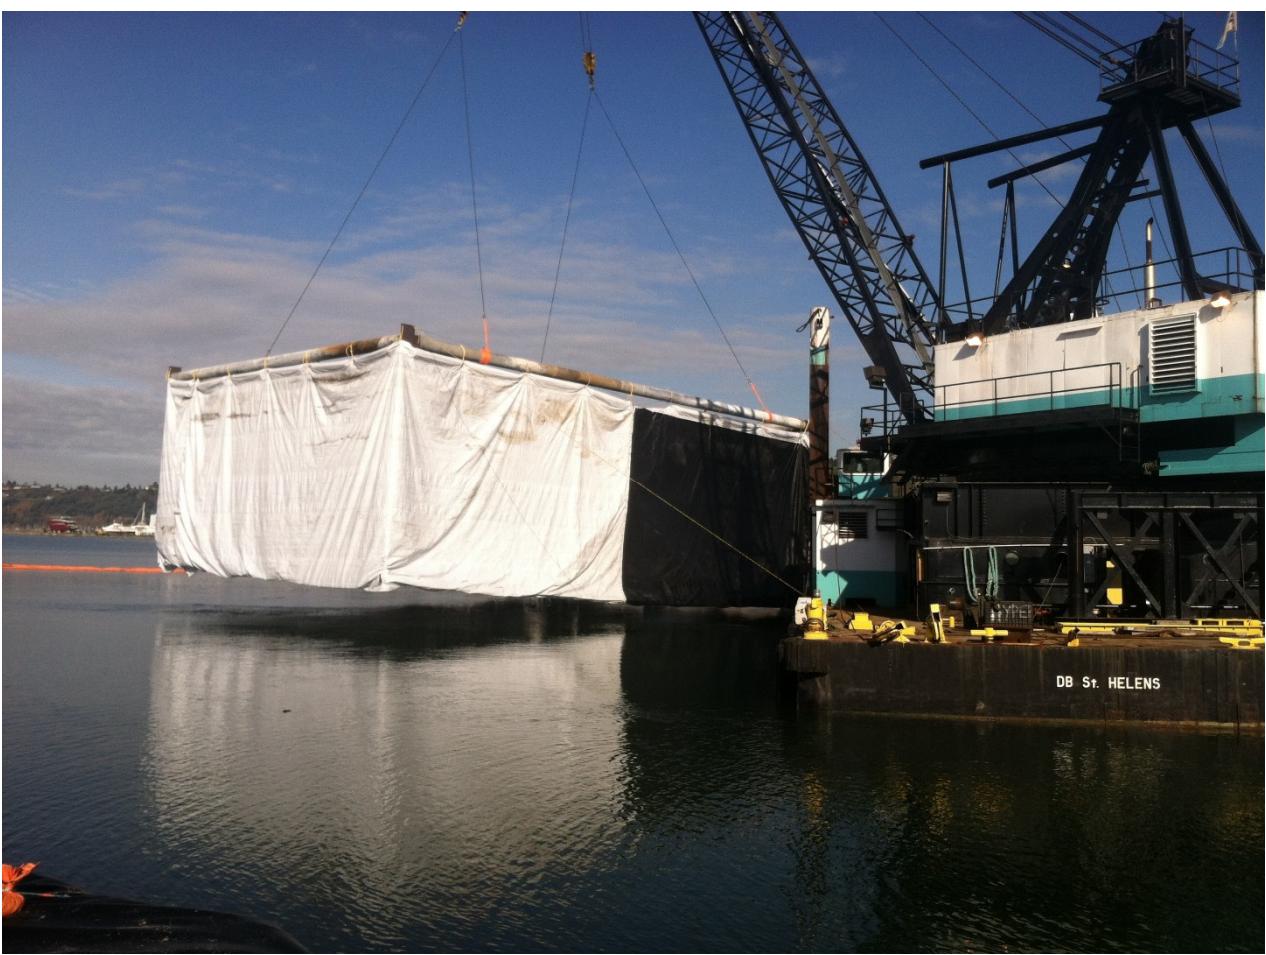
Photograph 16. Floating boom-supported turbidity curtain during deployment.

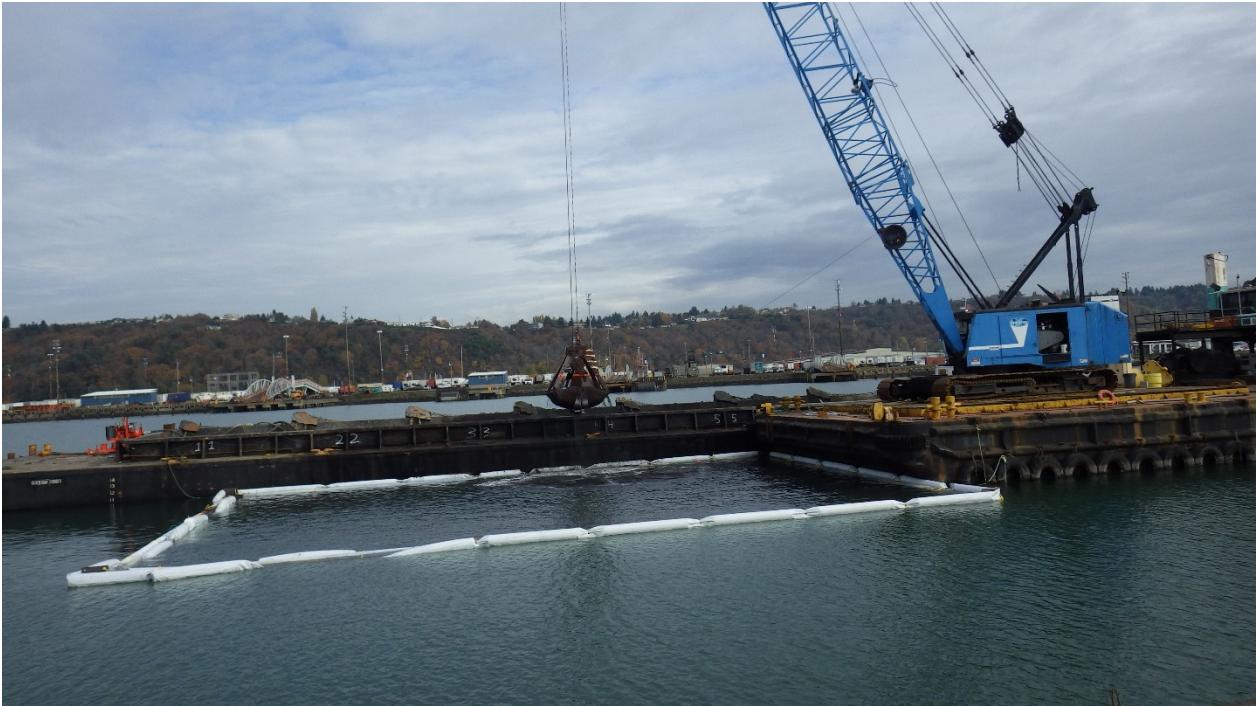
Photograph 17. Floating boom-supported turbidity curtain in use during hot spot dredging.

- **Evaluation of dredging BMPs in context with site conditions and other regional projects allowed for optimization of site-specific construction methods.** The ability to analyze common dredge BMPs, within the context of site conditions, and present the predicted effectiveness of the BMPs allowed for the joint identification of BMPs and construction methods that were tailored to the project. The project greatly benefited from lessons learned on other regional contaminated dredging projects. One example of this process was the use of a floating boom-supported silt curtain to protect water quality during hot spot dredging.

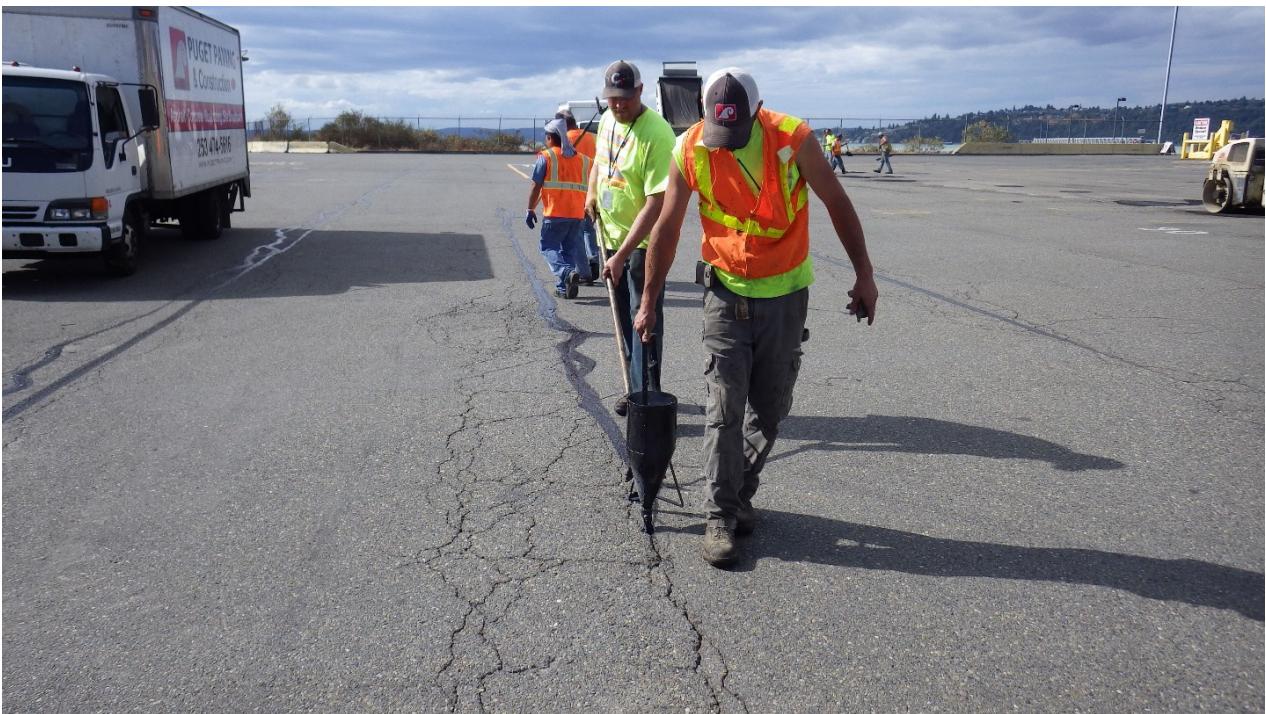
Photograph 18. Crack sealing at APM Terminals.

Waterway during transload activities. From August 5 to 7, 2015, Puget Paving sealed cracks over approximately 3.75 acres of APM Terminals (Appendix A, Photograph 18).

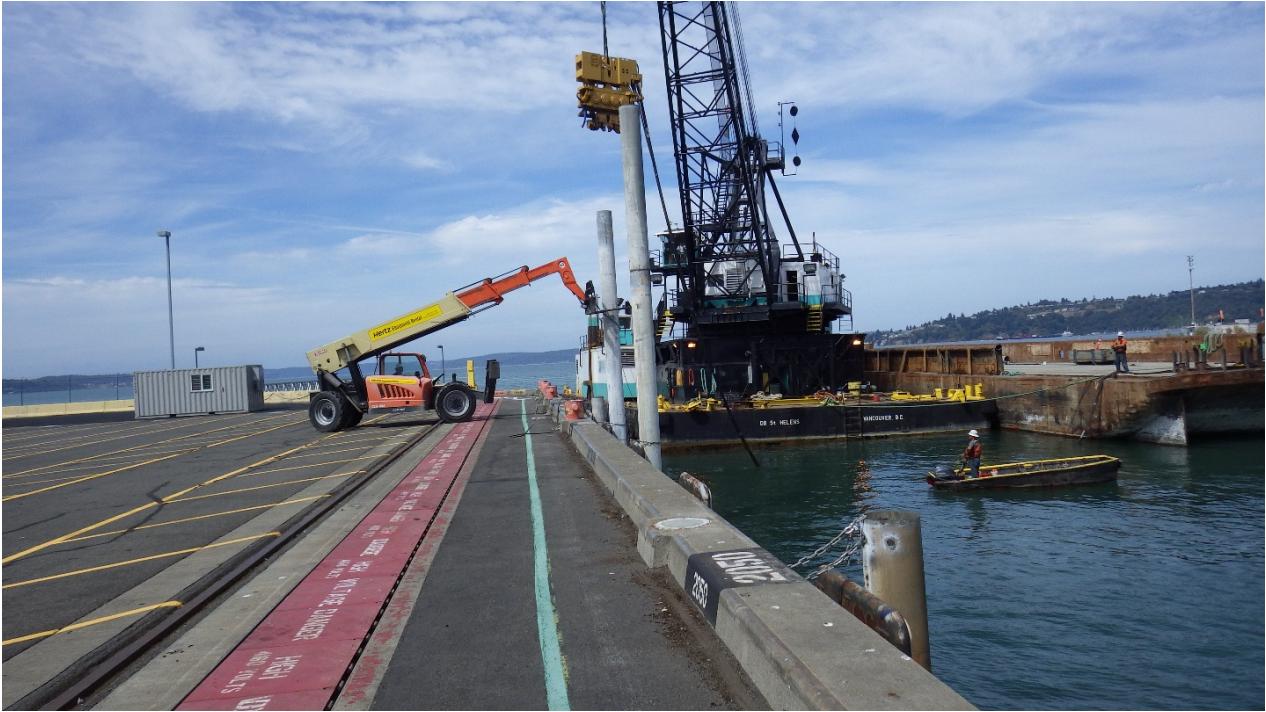
Photograph 19. Installation of temporary mooring steel piles at APM Terminals to protect the fender system.

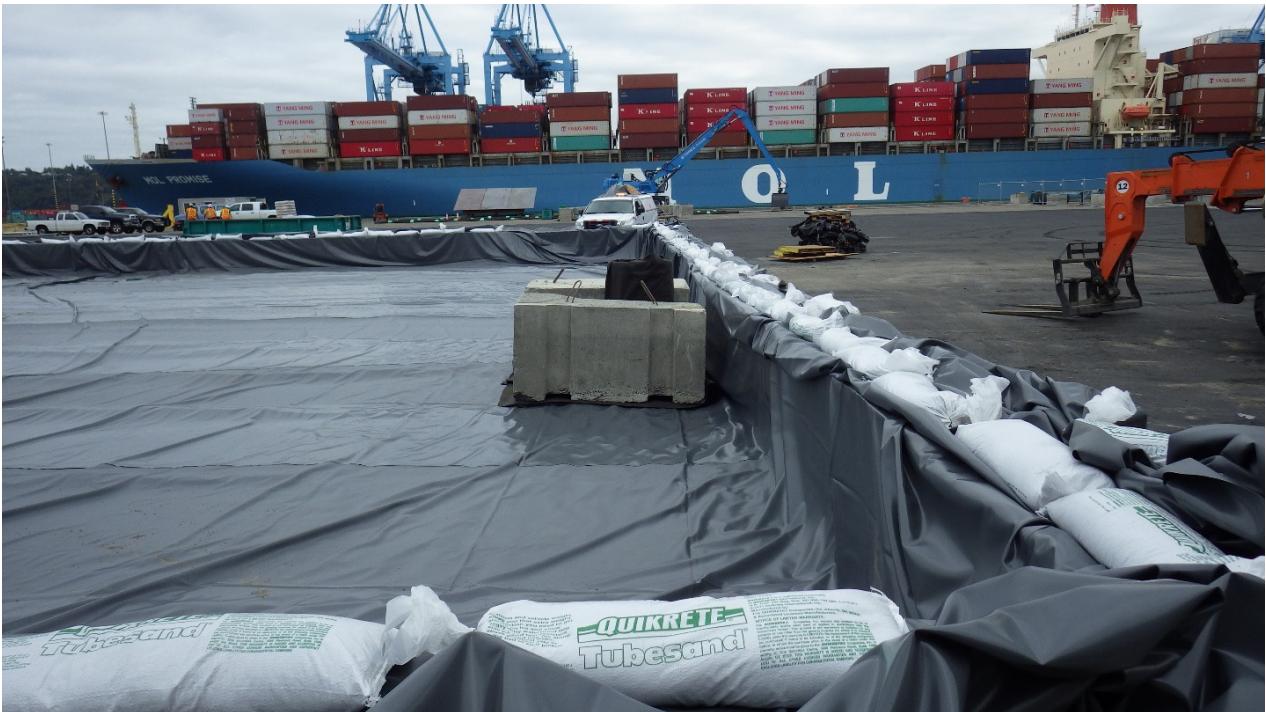
Photograph 20. Set up of the settling pond at APM Terminals.

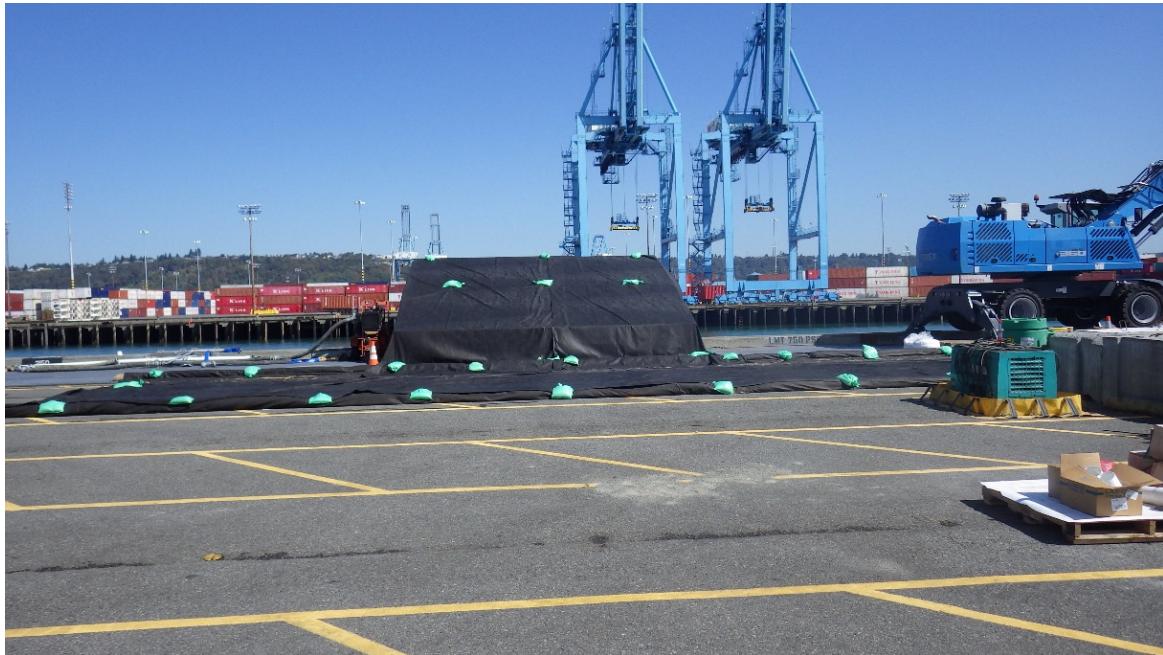
Photograph 21. Spill apron with filter fabric adjacent to edge of pier at APM Terminals.

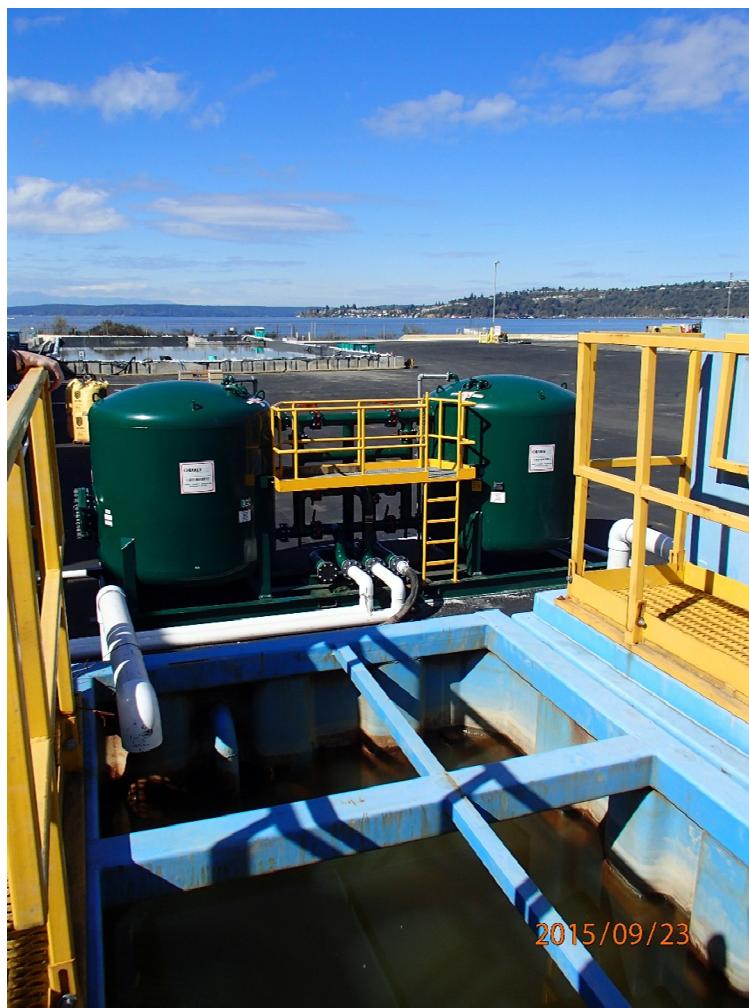
Photograph 22. Water treatment system and GAC filters at APM Terminals.

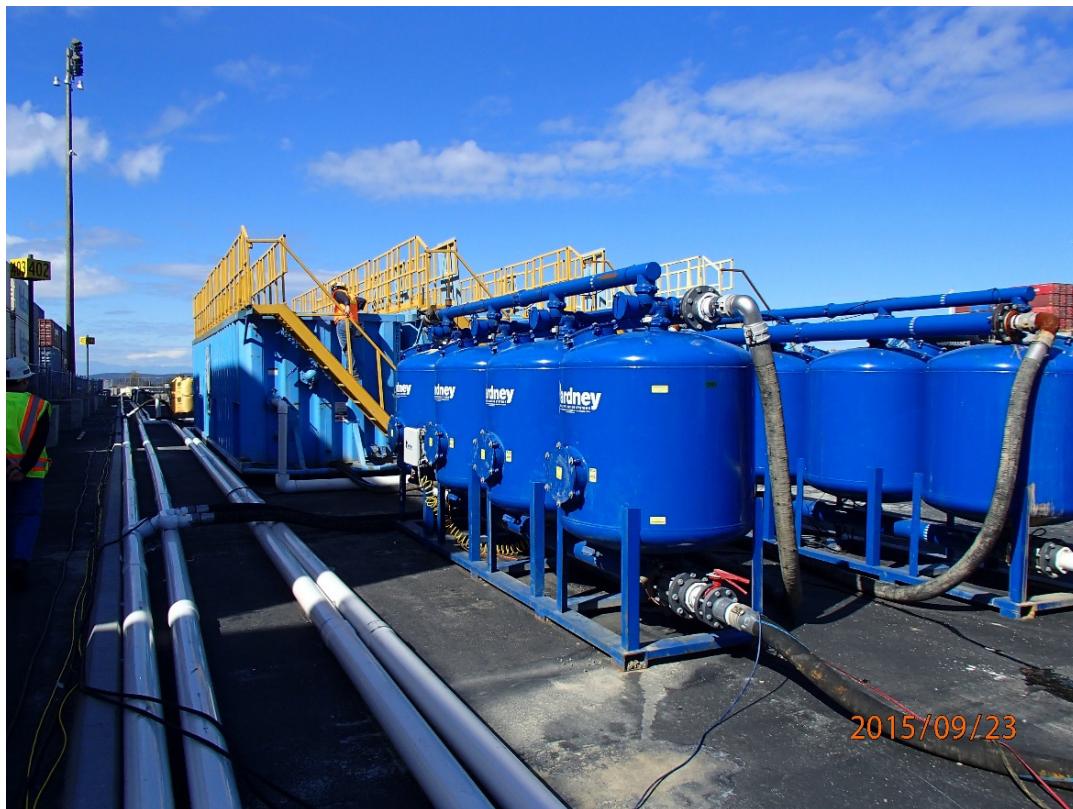
Photograph 23. Water treatment system media filters and weir tanks at APM Terminals.

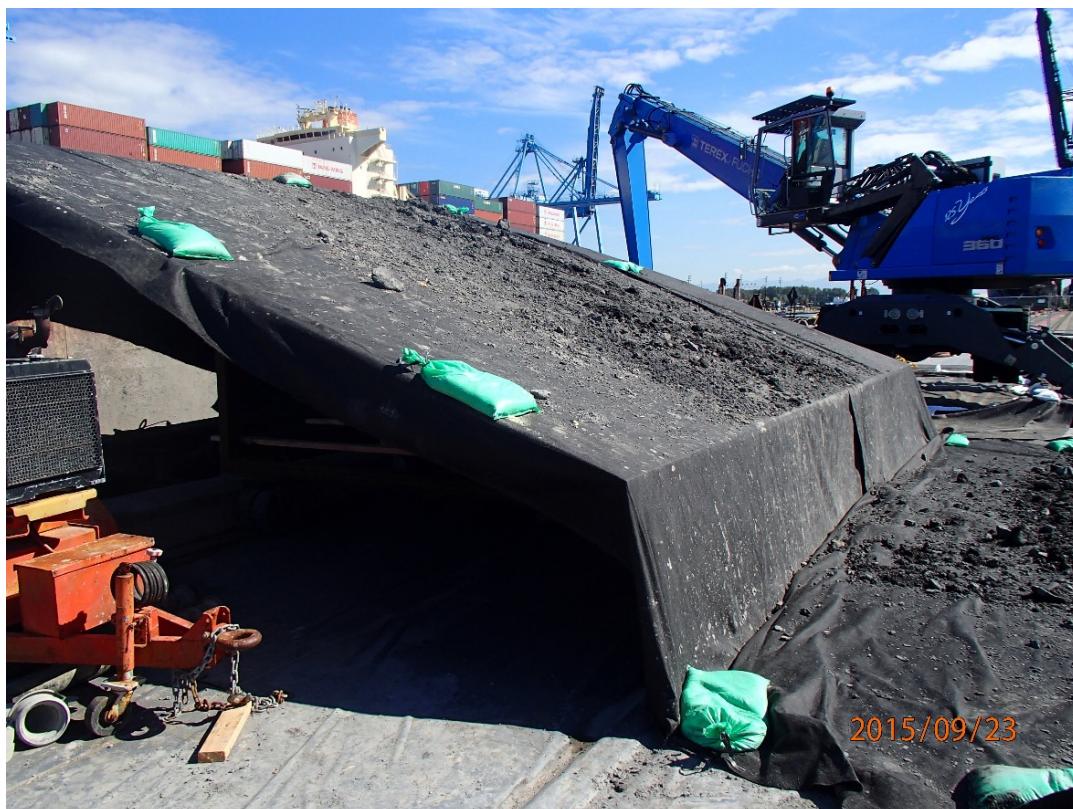
Photograph 24. Accumulated sediment on spill apron at APM Terminals.

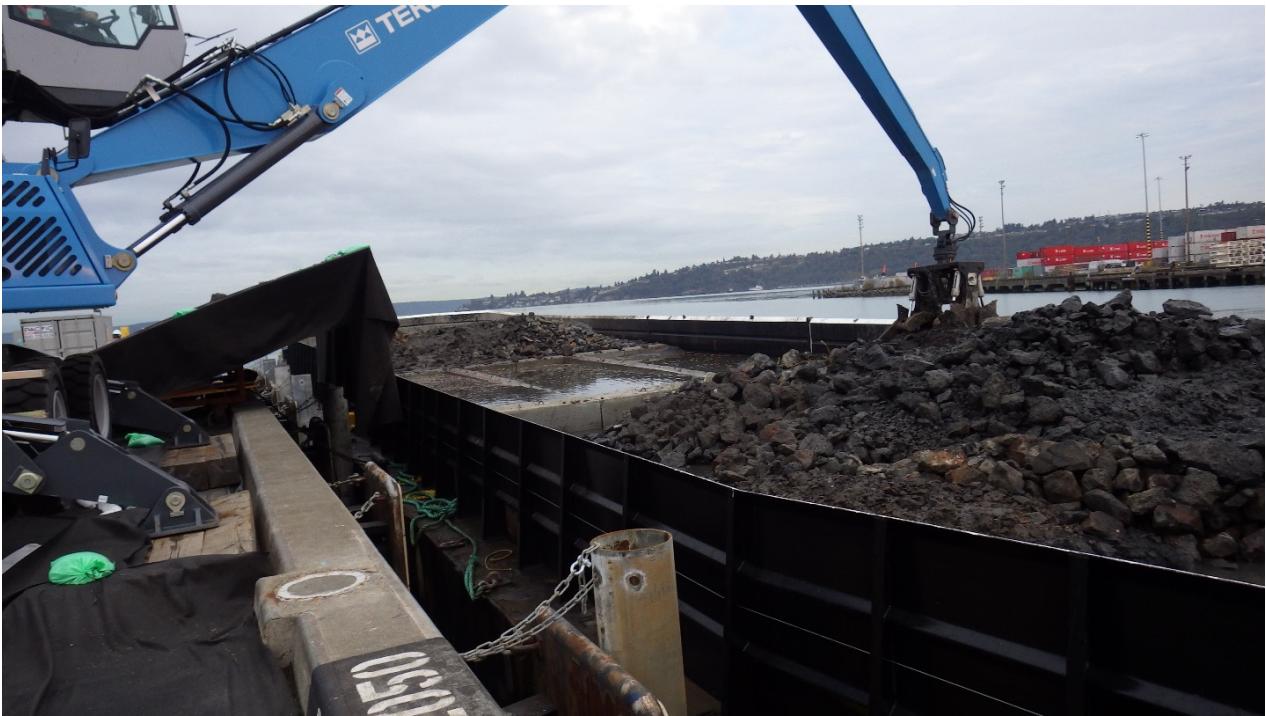
Photograph 25. Transloading of sediment and rock armoring at APM Terminals

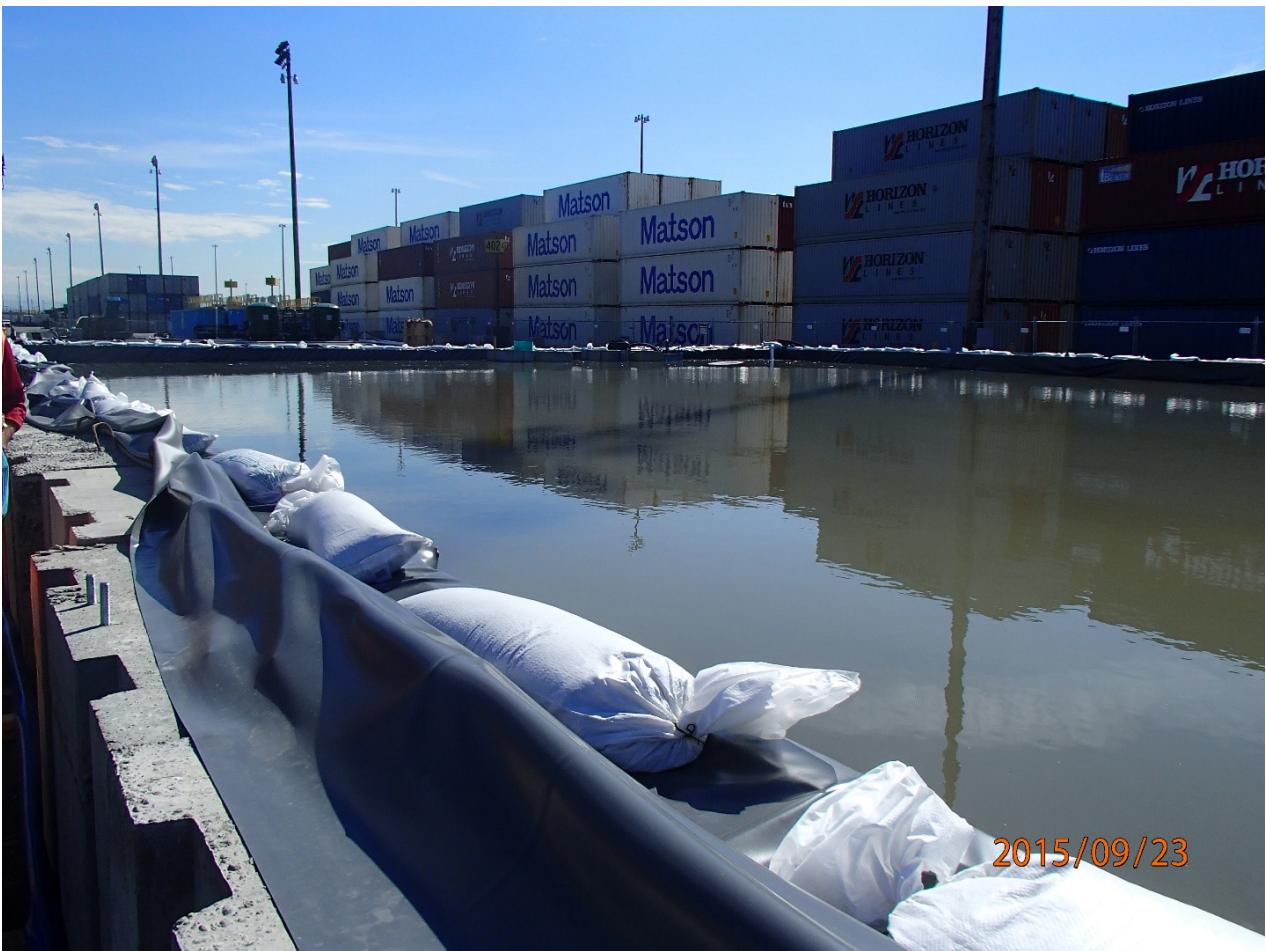
Photograph 26. Accumulated water in the settling pond at APM Terminals.

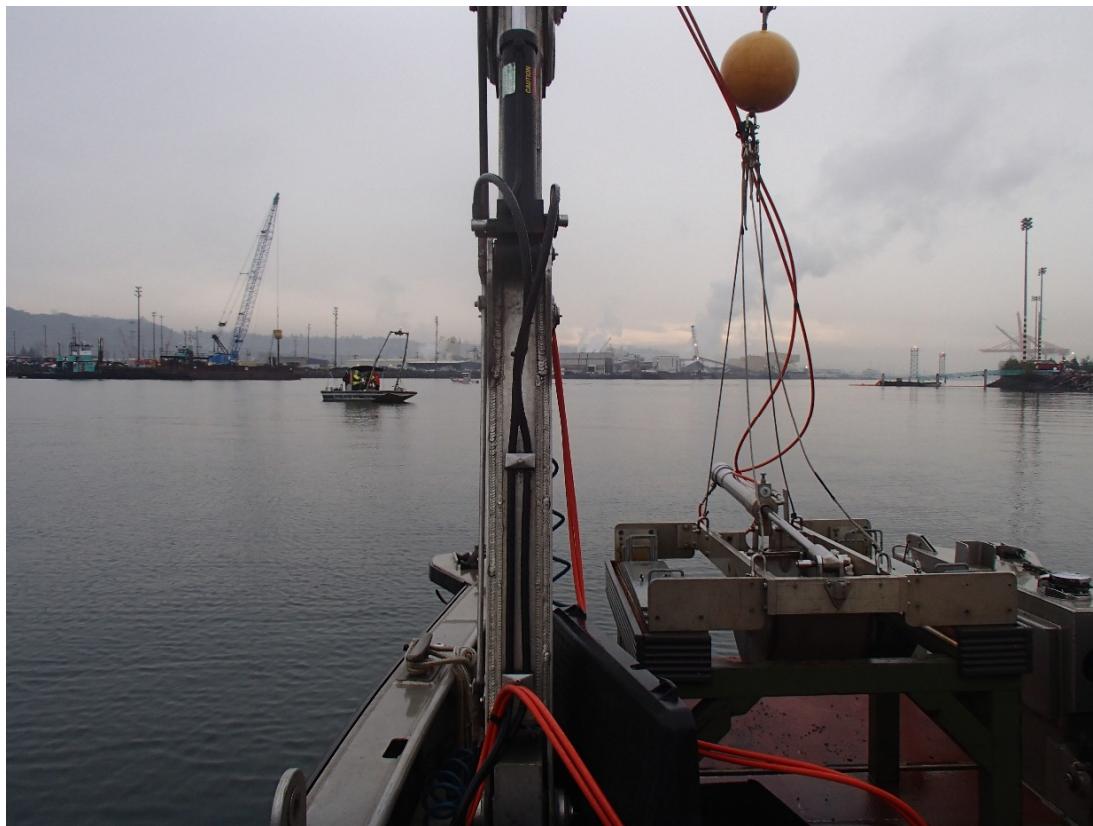
Photograph 27. Sediment sampling during first event.

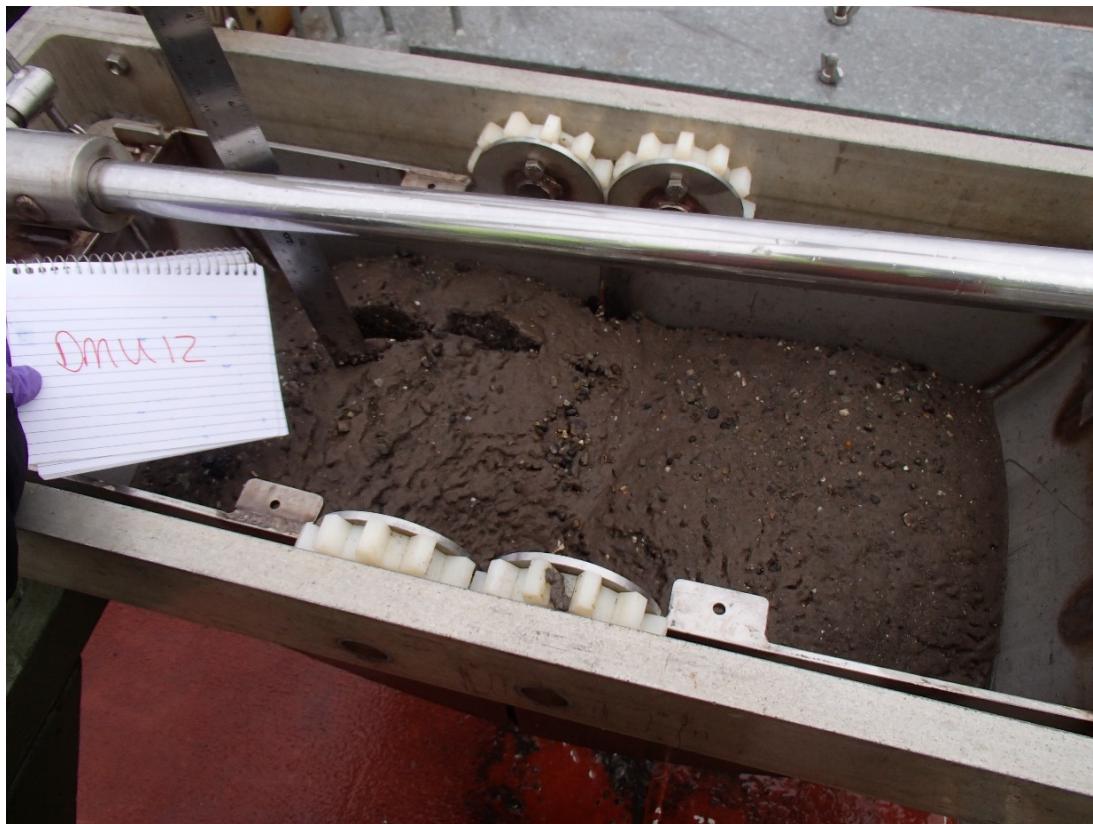
Photograph 28. Power grab sediment sample at DMU-12 during first sampling event.

Sediment observed in the majority of the grab samples was dark gray, poorly graded fine to medium sand and silty sand. Many of the sample grabs were overlain by a fine brown silt layer that was presumed to be dredge residuals, although there was no correlation between the presence of the surface silt layer and TBT concentrations. No odor or anthropogenic debris were noted.

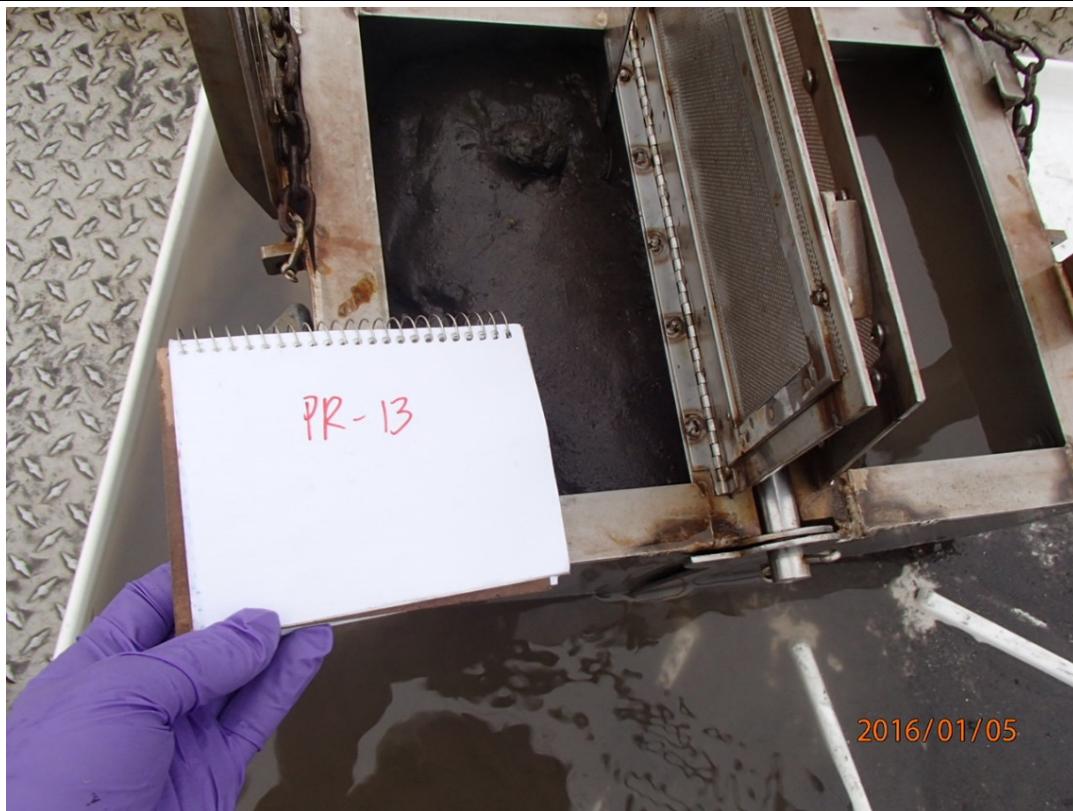
Photograph 29. Van Veen sediment sample at PR-13 during first sampling event.

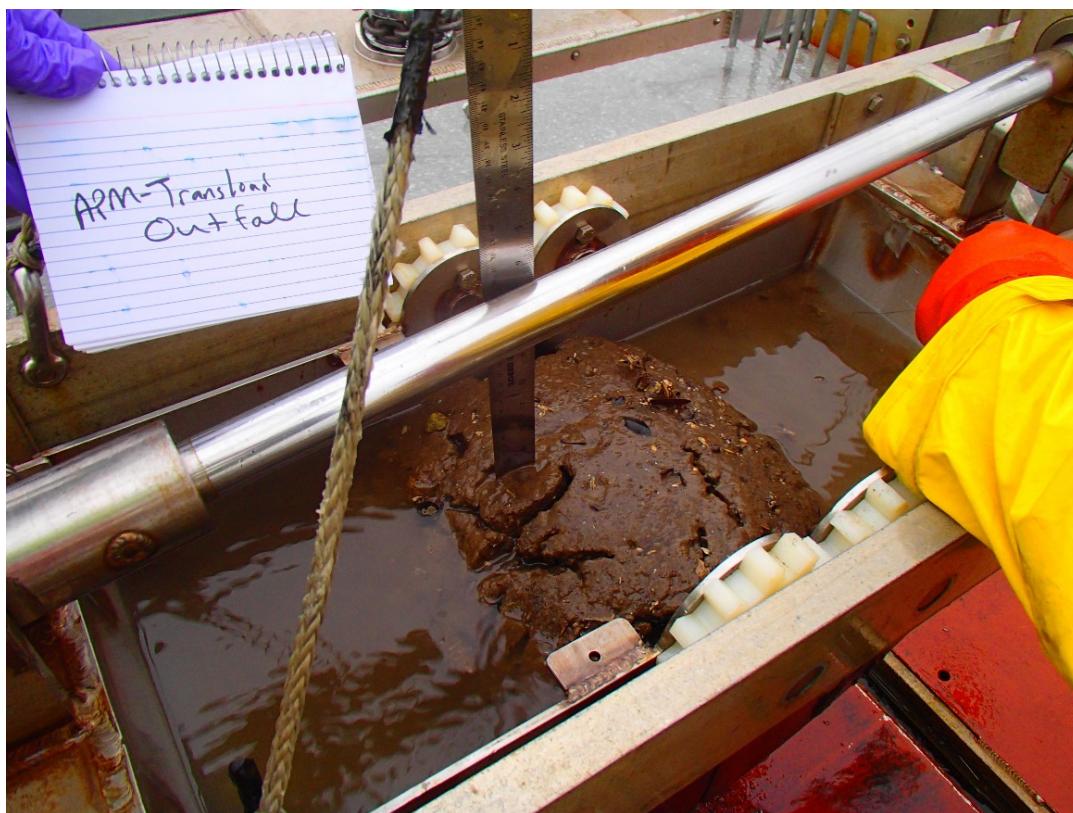
Photograph 30. Power grab sediment sample at the APM Terminals Transload outfall location during first sampling event.

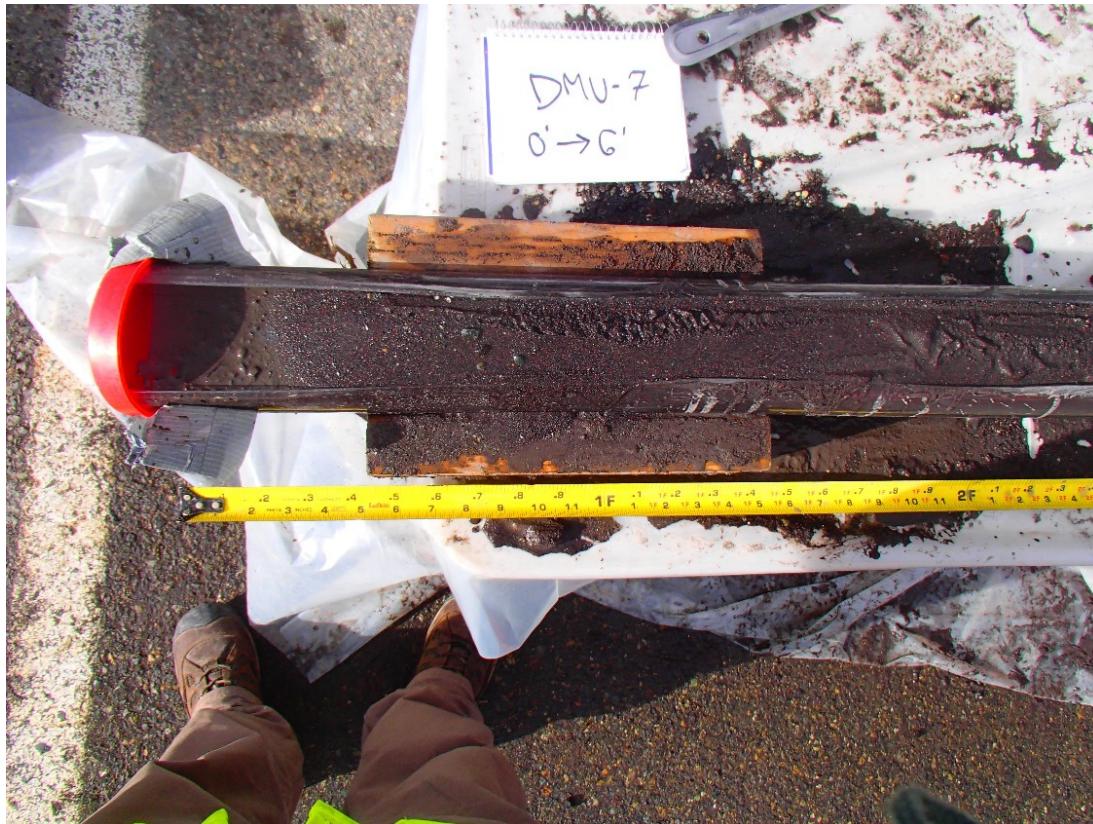
Photograph 31. Sediment core from DMU-7 during second sampling event.

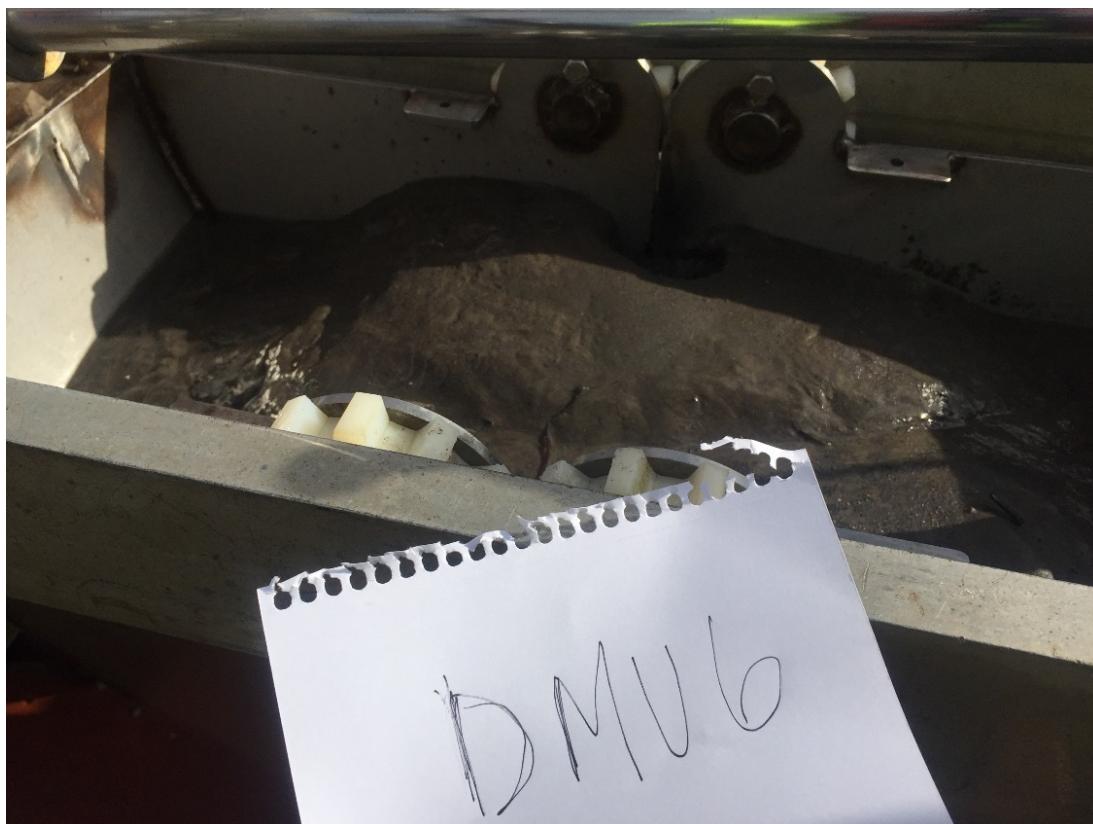
Photograph 32. Power grab sediment sample at DMU-6 during second sampling event.

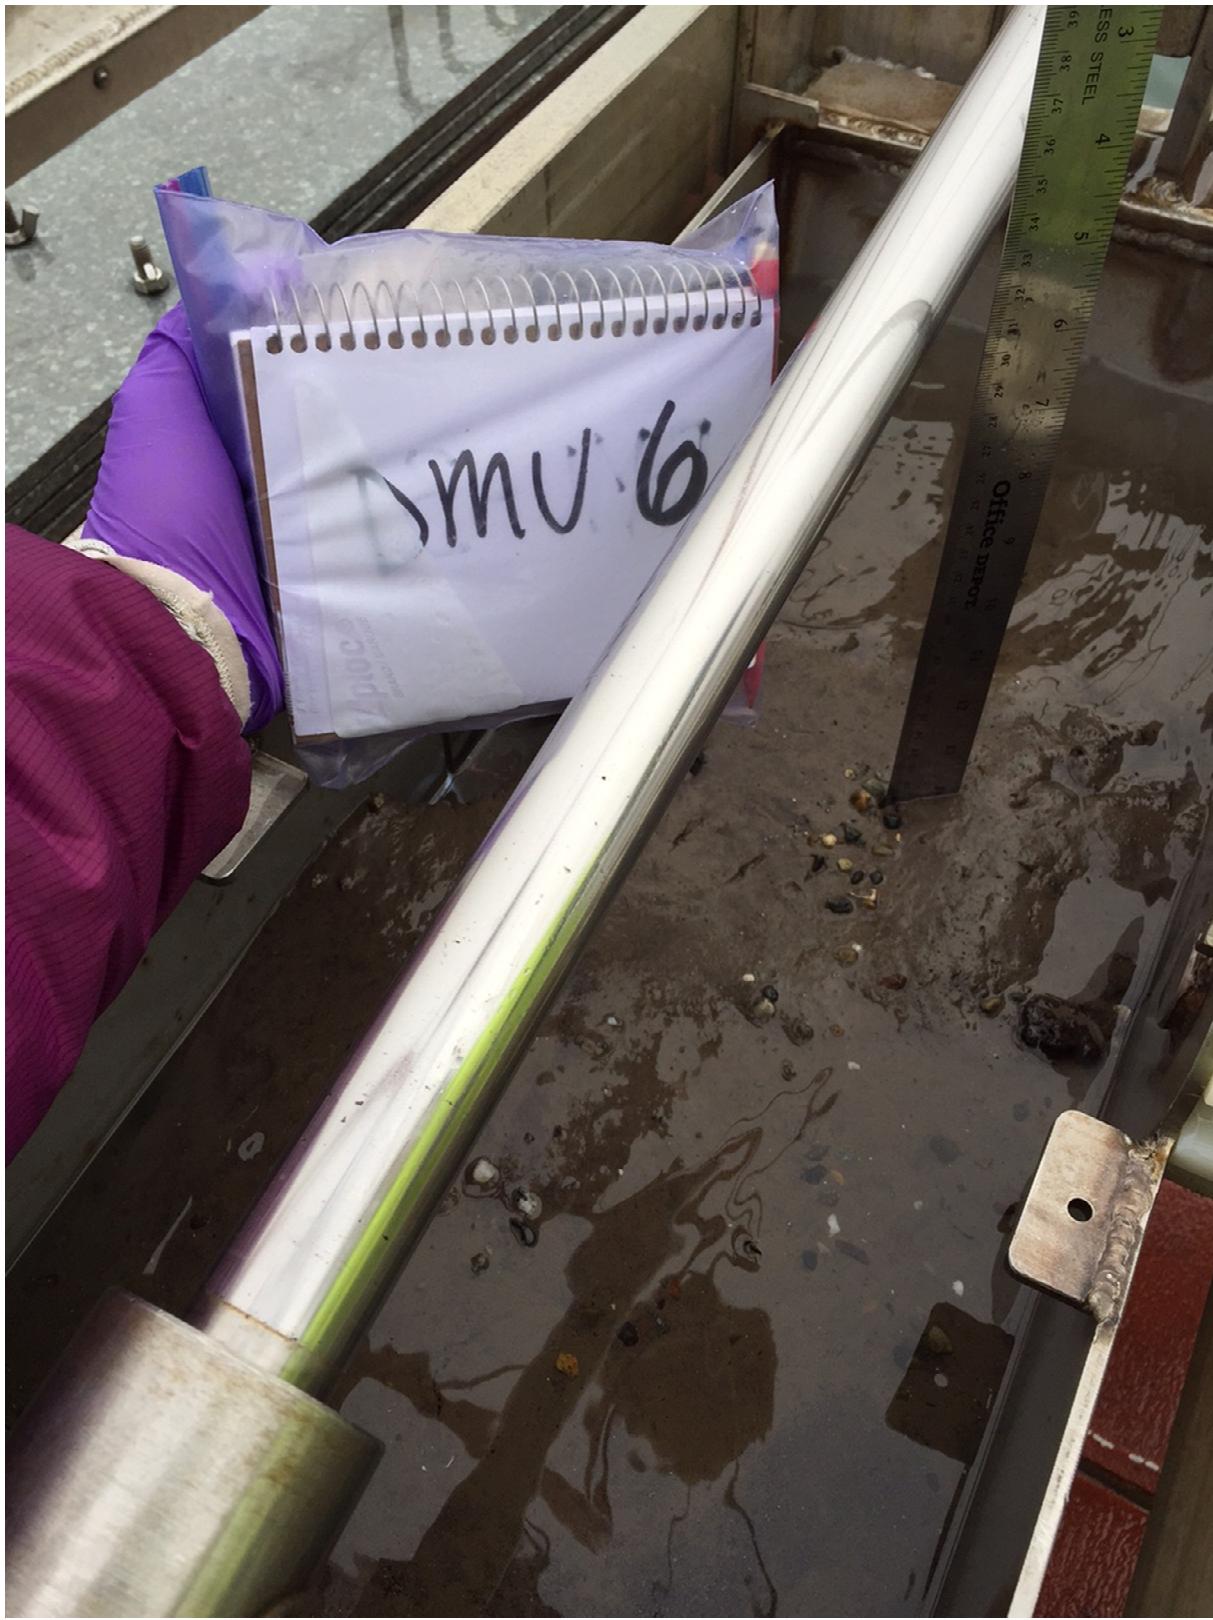
Photograph 33. Power grab sediment sample at DMU-6 during final sampling event.
